# LANDSLIDES IN HAMILTON COUNTY

Prepared by Robert E. Sheets, P.E., Geotechnical Engineer, Hamilton County Soil & Water Conservation District

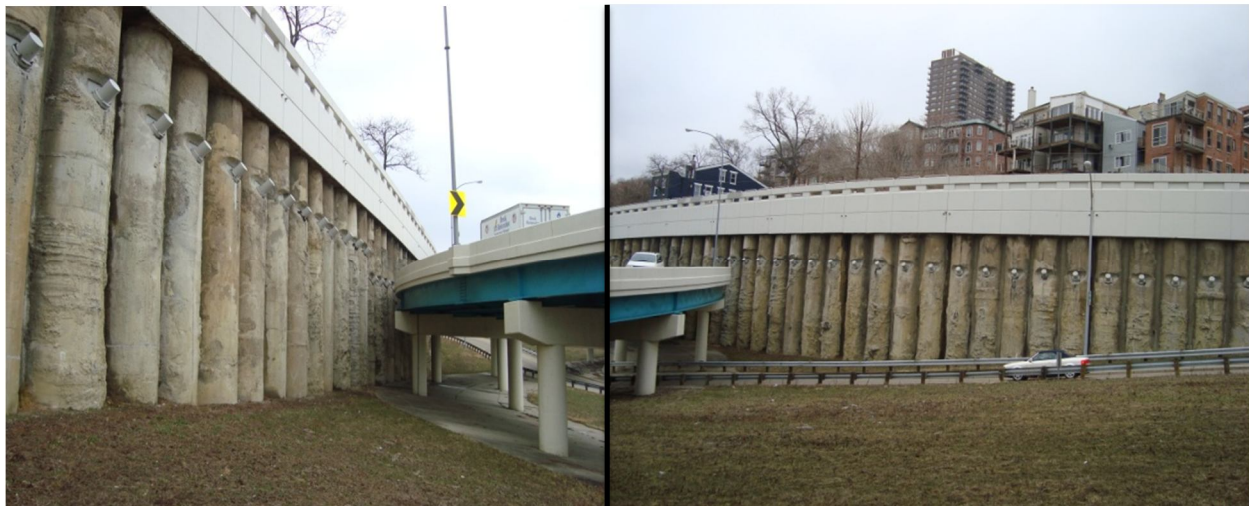
The Mt. Adams Retaining Wall.

Landslides in Hamilton County are not limited to those areas disturbed by our early pioneers. Problems with landslides have continued to this day. In fact, one of the most expensive retaining walls constructed in the United States sits at the base of Mount Adams. The retaining wall supports a slope which failed as a result of the construction of the I-471 cloverleaf near the southeast corner of downtown Cincinnati. The wall appears as a row of rather rough, vertical concrete cylinders (called “drilled piers”) extending up out of the ground, with what appear to be steel “top hats” extending from their sides. These “top hats” are actually caps for steel tendons, which extend to and are anchored in a tunnel behind the wall and deep in the earth below Mount Adams. These steel tendons hold or “tie-back” the top of the wall. The retaining wall system, known commonly as a “tied-back drilled pier retaining wall”, provides lateral support to the toe of the hillside, which in turn supports the entire slope and structures above. In fact, the drilled pier method of retaining wall construction is native to the Cincinnati area.

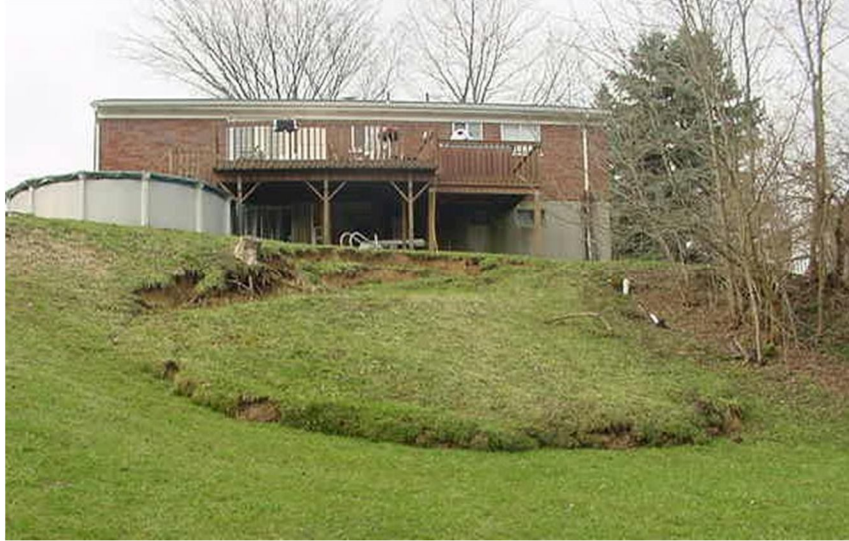
Photo of a small but typical residential landslide. Note the ground cracking at the top (scarp), and ground bulging at the bottom (toe), and the general downward and outward movement of earth.

While we in Hamilton County do experience rapidly-moving mudslide-type landslides (as are reported spilling onto Columbia Parkway most spring seasons), typical landslides here are best represented as slow-moving masses of clayey soil, in many instances only noticeable by cracks in the ground near the upper limit (called the "scarp") and by bulging soil at the lower limit (called the "toe") of the moving soil mass.

The rate of movement of these landslides (often after a more rapid initial "slump") is quite slow, varying from inches per day to inches per year, barely distinguishable as movement. Yet these landslides can continue for years, causing slow destruction of any man-made structures of which they come in contact. Houses, apartment buildings, streets and roadways are no match for the forces associated with such a landslide.

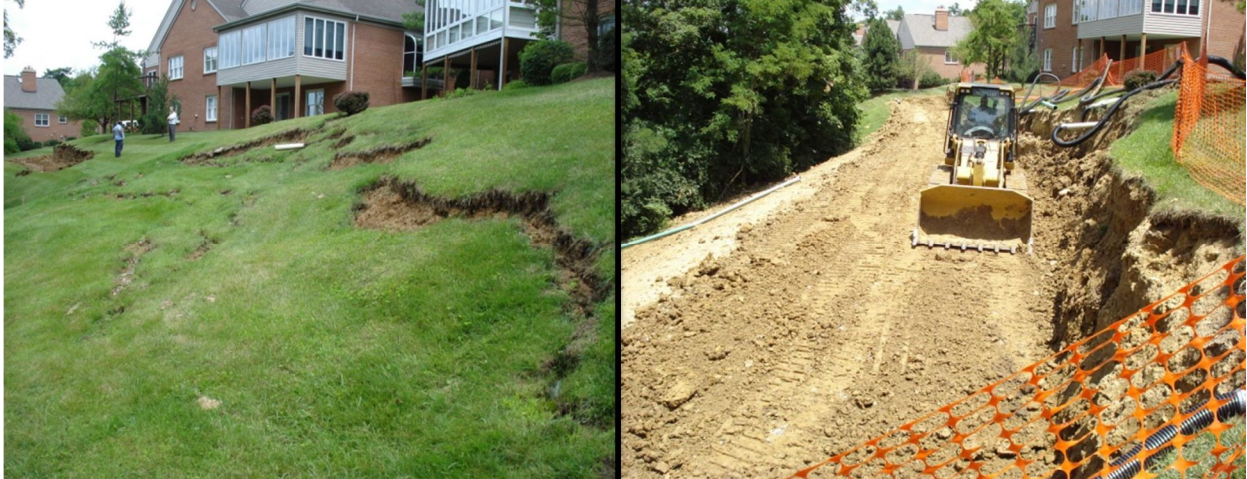
Typical residential landslide (left). Engineered repair of same (right).

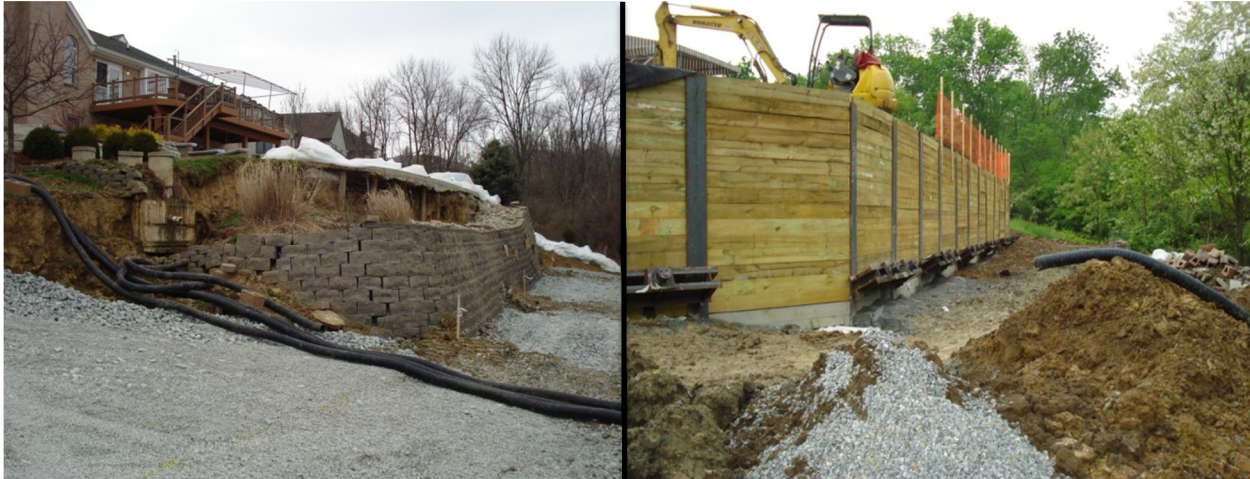
Results of a residential slope failure (left). Engineered repair of same (right).

Of the three generally considered the most severe, one necessitated the construction of a \$250,000 retaining wall to reestablish support for a single residential property. A second caused the complete destruction of a large, upscale apartment building, half of another building and required a \$2.5-million retaining wall to stabilize the property. The third was a failure of a slope bounded by a retail strip mall at the top and a condominium community at the bottom and did not outwardly affect any of the structures involved. Nonetheless, due to the threat of damage and unsafe conditions, the landslide resulted in the closing of six to eight local businesses, with undoubted financial impact to those businesses that remained open. The condominiums which neighbored the landslide were also undoubtedly affected in terms of value as well as saleability, in addition to the personal burden to the owners. In the three years following its occurrence, this last described landslide had not been repaired. A slope repair is currently in progress, estimated at roughly \$2- to \$4-million.
