LANDSLIDES IN HAMILTON COUNTY

Prepared by Robert E. Sheets, P.E., Geotechnical Engineer, Hamilton County Soil & Water Conservation District

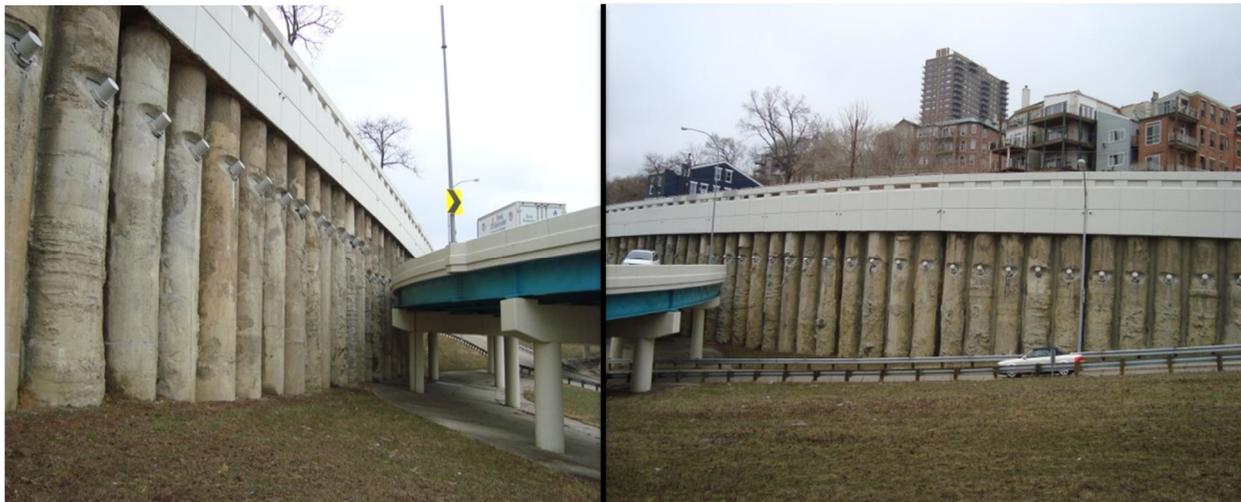
The Mt. Adams Retaining Wall.

Landslides in Hamilton County are not limited to those areas disturbed by our early pioneers. Problems with landslides have continued to this day. In fact, one of the most expensive retaining walls constructed in the United States sits at the base of Mount Adams. The retaining wall supports a slope which failed as a result of the construction of the I-471 cloverleaf near the southeast corner of downtown Cincinnati. The wall appears as a row of rather rough, vertical concrete cylinders (called “drilled piers”) extending up out of the ground, with what appear to be steel “top hats” extending from their sides. These “top hats” are actually caps for steel tendons, which extend to and are anchored in a tunnel behind the wall and deep in the earth below Mount Adams. These steel tendons hold or “tie-back” the top of the wall. The retaining wall system, known commonly as a “tied-back drilled pier retaining wall”, provides lateral support to the toe of the hillside, which in turn supports the entire slope and structures above. In fact, the drilled pier method of retaining wall construction is native to the Cincinnati area.

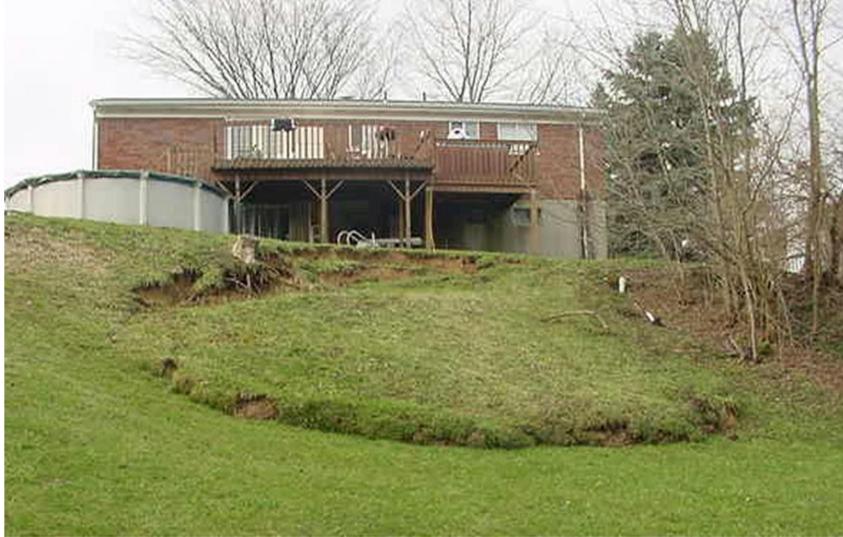
Photo of a small but typical residential landslide. Note the ground cracking at the top (scarp), and ground bulging at the bottom (toe), and the general downward and outward movement of earth.

While we in Hamilton County do experience rapidly-moving mudslide-type landslides (as are reported spilling onto Columbia Parkway most spring seasons), typical landslides here are best represented as slow-moving masses of clayey soil, in many instances only noticeable by cracks in the ground near the upper limit (called the "scarp") and by bulging soil at the lower limit (called the "toe") of the moving soil mass.

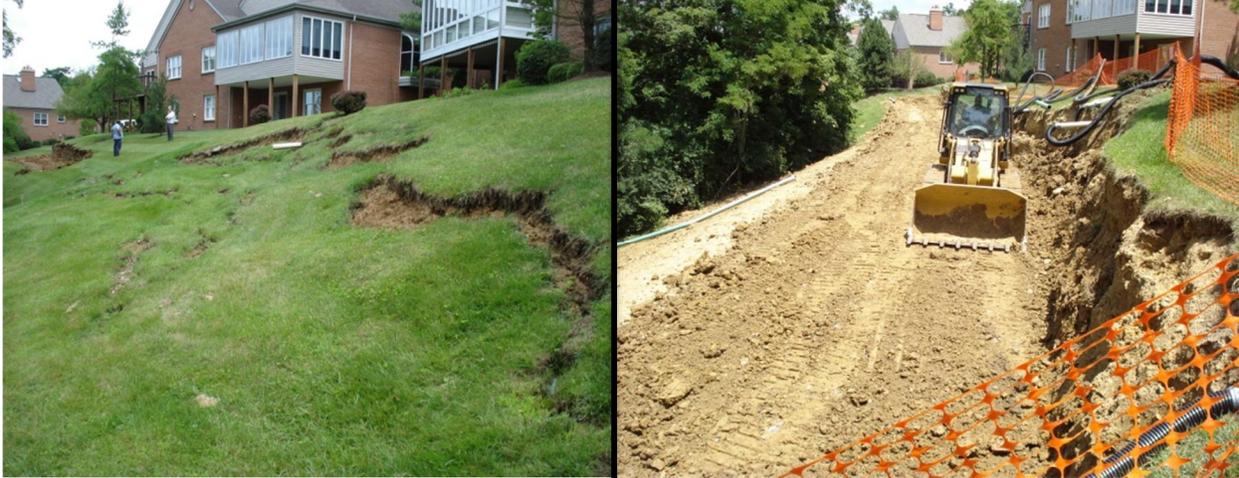
Typical residential landslide (left). Engineered repair of same (right).

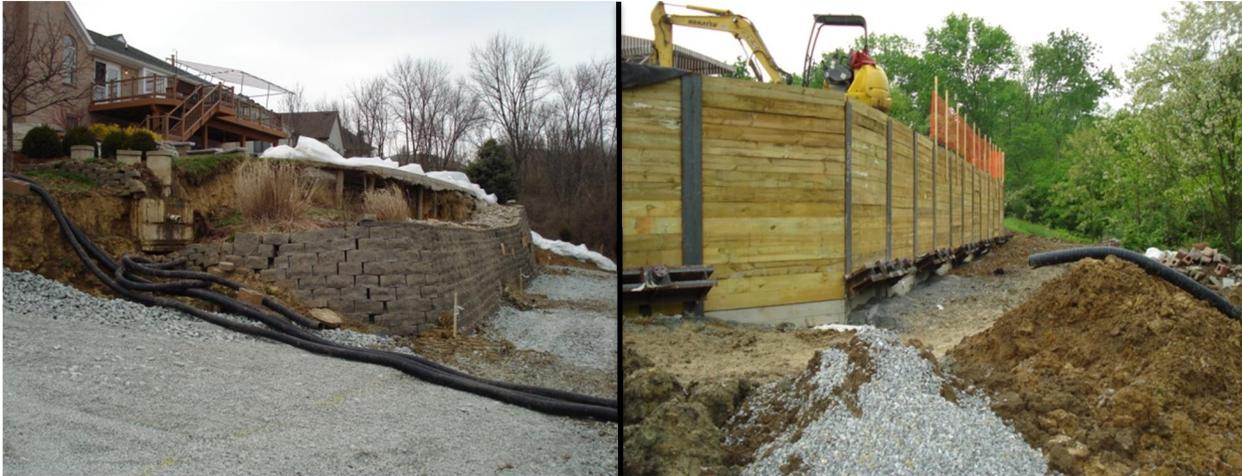
Results of a residential slope failure (left). Engineered repair of same (right).

Of the three generally considered the most severe, one necessitated the construction of a \$250,000 retaining wall to reestablish support for a single residential property. A second caused the complete destruction of a large, upscale apartment building, half of another building and required a \$2.5-million retaining wall to stabilize the property. The third was a failure of a slope bounded by a retail strip mall at the top and a condominium community at the bottom and did not outwardly affect any of the structures involved. Nonetheless, due to the threat of damage and unsafe conditions, the landslide resulted in the closing of six to eight local businesses, with undoubted financial impact to those businesses that remained open. The condominiums which neighbored the landslide were also undoubtedly affected in terms of value as well as saleability, in addition to the personal burden to the owners. In the three years following its occurrence, this last described landslide had not been repaired. A slope repair is currently in progress, estimated at roughly \$2- to \$4-million.
